# Evaluation Report 301

## Melroe Model 116-78 Sprague

# MELROE MODEL 116-78 SPRA-COUCPE

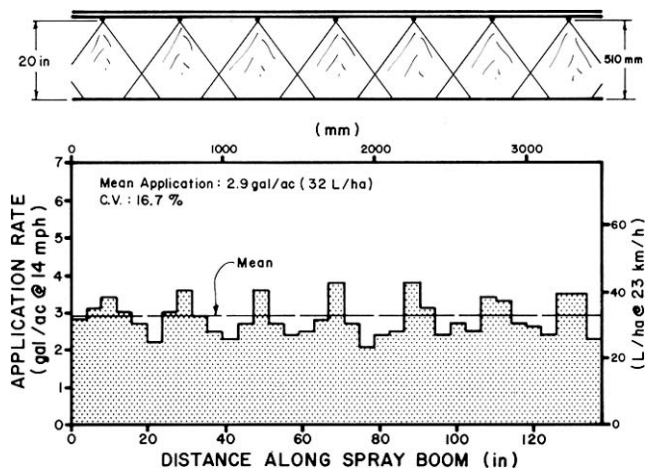
FIGURE 2. Typical Distribution Pattern along the Boom at 22 psi (150 kPa) with Spraying Systems 730231 Brass Nozzles, at a 20 in (510 mm) Nozzle Height.

to 550) kPa). FIGURES 2 and 3 show spray distribution patterns along the boom with Tee Jet 730231 nozzles when operated at a 20 in (510 mm) nozzle height. The coefficient of variation (CV)<sup>1</sup> at 22 psi (150 kPa) (FIGURE 2) was 16.7%, with application rates along the boom varying from 2.2 to 3.9 gal/ac (24 to 43 L/ha) at 14 mph (23 km/h). High spray concentrations occurred below each nozzle with inadequate coverage between nozzles. At 44 psi (300 kPa) (FIGURE 3) the distribution pattern improved considerably, reducing the CV to 5.9%. Application rate along the boom varied from 3.6 to 4.5 gal/ac (40 to 50 L/ha) at 14 mph (23 km/h). High pressures improved distribution by increasing the overlap and capacity among nozzles. Higher pressure, however, usually causes more spray drift.

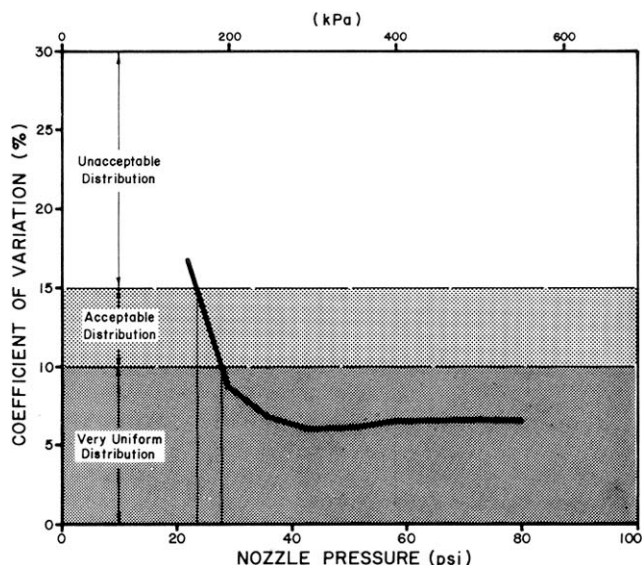
FIGURE 4. Spray Pattern Uniformity for TeeJet 730231 Brass Nozzles Operated at a 20 in (510 mm) Nozzle Height.

FIGURE 4. shows how nozzle pressure affected pattern uniformity for the TeeJet 730231 flat fan nozzles. The new brass nozzles produced acceptable distribution patterns at pressures above 23 psi (160 kPa) and very uniform patterns at pressures above 28 psi (190 kPa). After 51 hours of field use, there was no significant change in spray pattern uniformity.

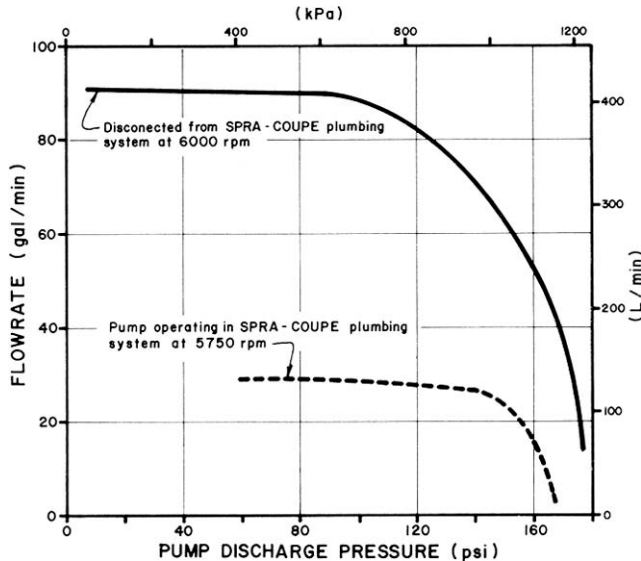
FIGURE 11. Pump Performance Curves.

**Output:** FIGURE 11 gives the pump performance curve for the Hypro 9202C centrifugal pump, when disconnected from the Spra-Coupe plumbing system and operated at 6000 rpm. The maximum pump output was 91 gal/min (415 L/min) at a pressure of 177 psi (1220 kPa). Pump output at 6000 rpm was similar to the manufacturer's rated output. Pump wear was negligible after 117 hours of field operation.

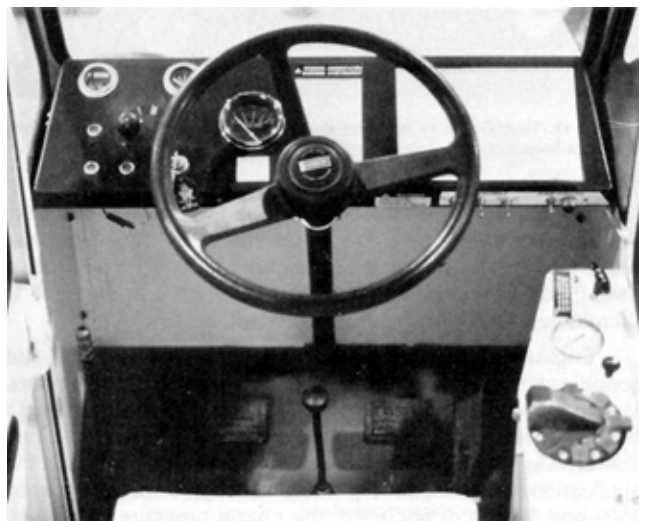
FIGURE 12. Control and Instrument Layout.

**Instruments:** The instrument panel (FIGURE 12) included gauges for engine hours, engine speed, control valve pressure and fuel. Warning lights were provided for engine oil pressure, coolant temperature and the electrical system alternator. The air cleaner condition indicator was located inside the engine housing and was easily seen when servicing the engine.

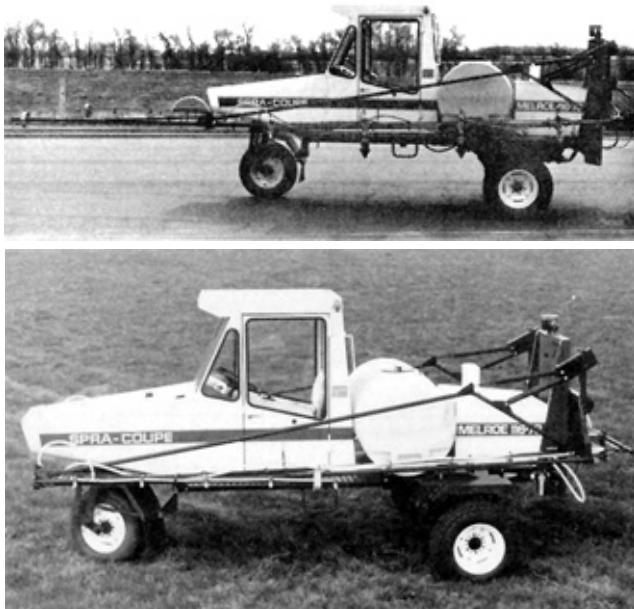
FIGURE 13. Spra-Coupe in Transport Position: (Upper) Partial Transport, (Lower) Complete Transport.
